University of Tartu  
Faculty of Arts and Humanities  
Institute of History and Archaeology  
Department of Archaeology

A 17TH CENTURY FLUIT WRECK IN GULF OF FINLAND

MA dissertation

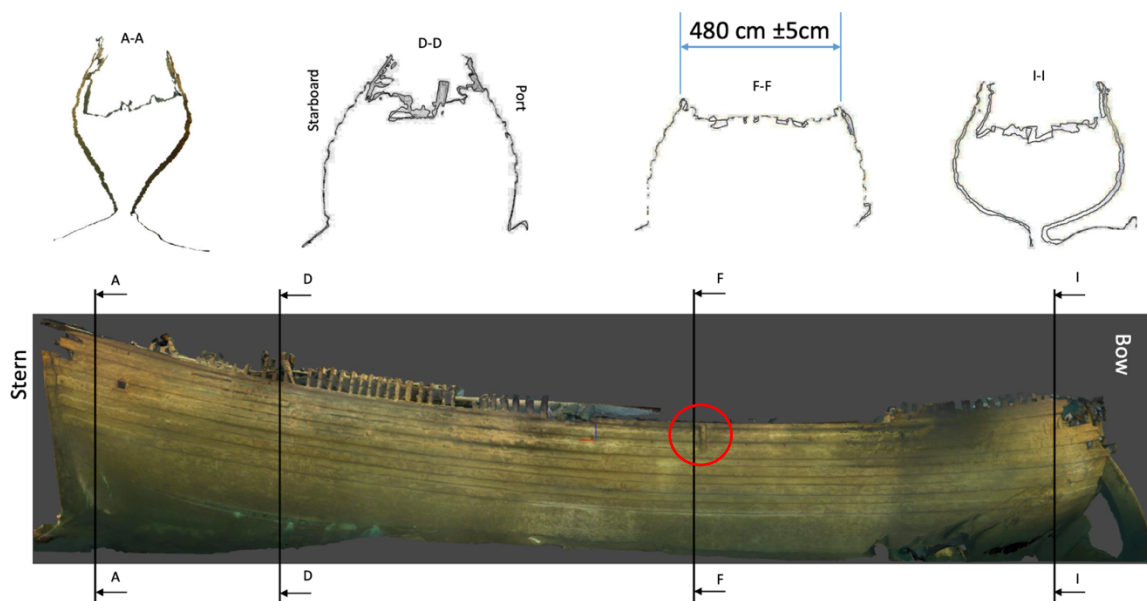
The size of the vessel is an important factor when researching a wreck. For example, measurements can be compared against historical data to determine the ship type. According to Unger (1994, 126) *fluits* that were built for the Baltic trade had mostly length-to-breadth ratio of 5:1 or 6:1 and length of the vessel was between 30–40 meters though it is now known that smaller *fluits* were also used (ie. "Jutholmen Wreck", "The Lion Wreck" and the "Ghost Ship"). 5:1 ratio of a 30-meter ship has a beam of about 6 meters and in case of 6:1 ratio about 5 meters. Since *fluits* had a characteristic tumblehome, the deck is considerably narrower than the beam. To take the measurements from the 3D model, it was necessary to establish a reference point. For that, two measurements were taken from the same predetermined place on the deck to decrease the possibility of error. The measurements were taken from the place where there are two "rope guides" on the outside of the hull (see figure 2). On both times a measuring tape on a roll was used and the result was 480 cm both times. From the cross-sections of the hull (figure 2), the pear-shape (sometimes also called a champagne glass shape) of a *fluit* is clearly visible.

**Figure 2.** The place where the measurement was taken is marked with red circle (Jouni Polkko 2021).

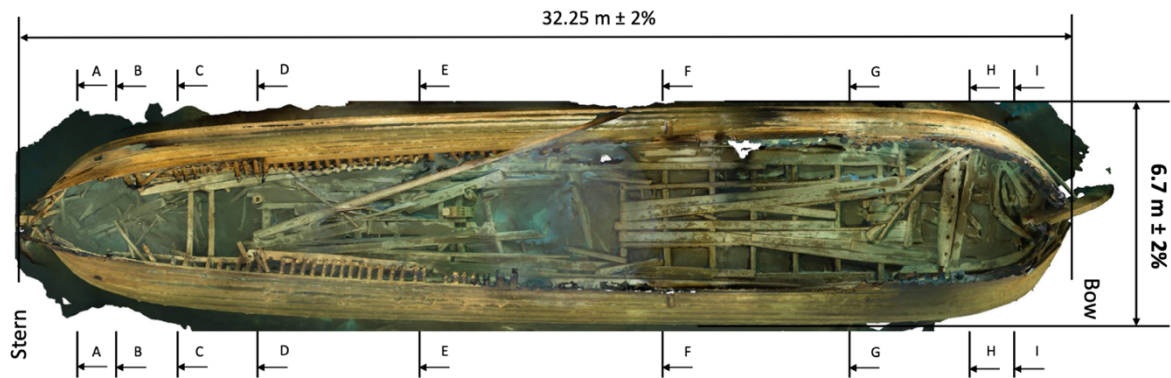
Another hull width measurement was taken from further to the bow, just below the front cargo hatch (figure 3, location G). Result – 490 cm. From these measurements it is possible to calculate other dimensions of the wreck.

**Figure 3.** Measurements of the wreck (Jouni Polkko 2021).

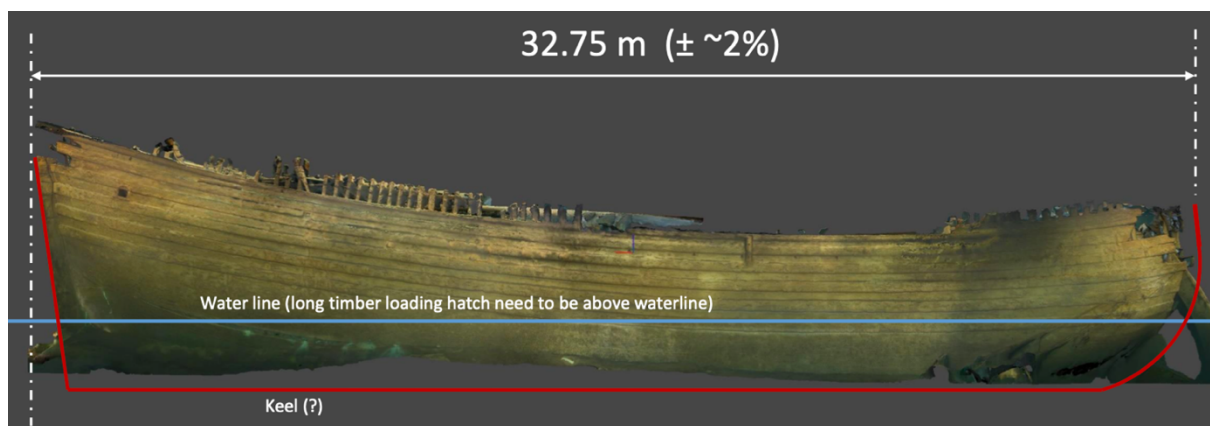
**Figure 4.** Stem post to stern post reconstruction and measurement (Jouni Polkko 2021).

The beam of the ship is 6.7 meters. These measurements give the length-to-breadth ratio of 5:1 which is a standard ratio for *fluits*. These vessels were usually rated between 200 – 500 tons (Barbour 1930, 280). According to Nicholaes Witsen (cited in Unger 1994, 122) a *fluit* of 32.5m in length and 6.65m in breadth would be rated to 300 tons. These measurements correspond almost exactly to the measurements of the *fluit* discussed in this paper, so it is safe to assume she was also rated to about 300 tons.

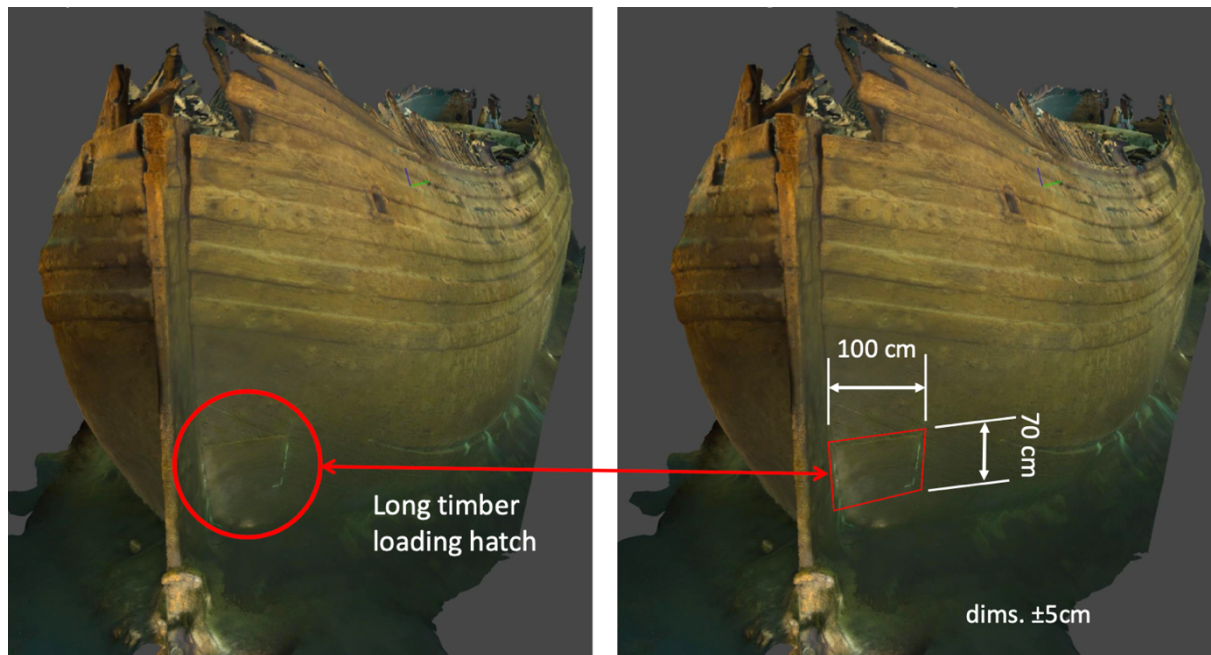
Next to the sternpost on starboard side there is a cargo hatch that could be used for loading long timbers or other tall objects (Van Beylen 1977, 31; Eriksson 2014, 56). The lower edge of the hatch had to be just above the waterline for the ease of loading of timbers, so it gives an indication of the approximate freeboard the vessel had. Sitting so close to the water meant that the opening must be as watertight as possible, so after covering the hatch it was heavily caulked (Unger 1994, 126). Dimensions of the hatch were measured underwater with measuring tape and the height of the hatch is 70 cm and the width is 100 cm (figure 5). The hull has a crack between the planks on the starboard side running abaft from the last third of the hull. It is unlikely that this is the reason for sinking thought at this stage it cannot be dismissed. It is more likely that the crack is a result of aging and/or from the tensions that may run through the wreck when she was caught in the trawl. There must have been considerable forces at play if the stempost has been broken in two and it has fallen inward. This shows that the force applied to the stempost was dragging it towards the stern. This would mean that the bow would become lighter during the drag, and the centre of mass would move towards the stern. Such mass redistribution may cause the planking to curve outwards and possibly resulting in a crack, especially after being hundreds of years underwater. Even when not disturbed, old wrecks tend to reshape on the seabed (Eriksson 2012, 19). It may be another reason for the crack. At this stage it is impossible to say with any certainty what has caused the crack. Also, it must be noted that some of the elements of the ship are most likely irrevocably lost because of the trawling.

**Figure 5.** Location and measurements of the hatch for loading tall objects (Jouni Polkko 2021).

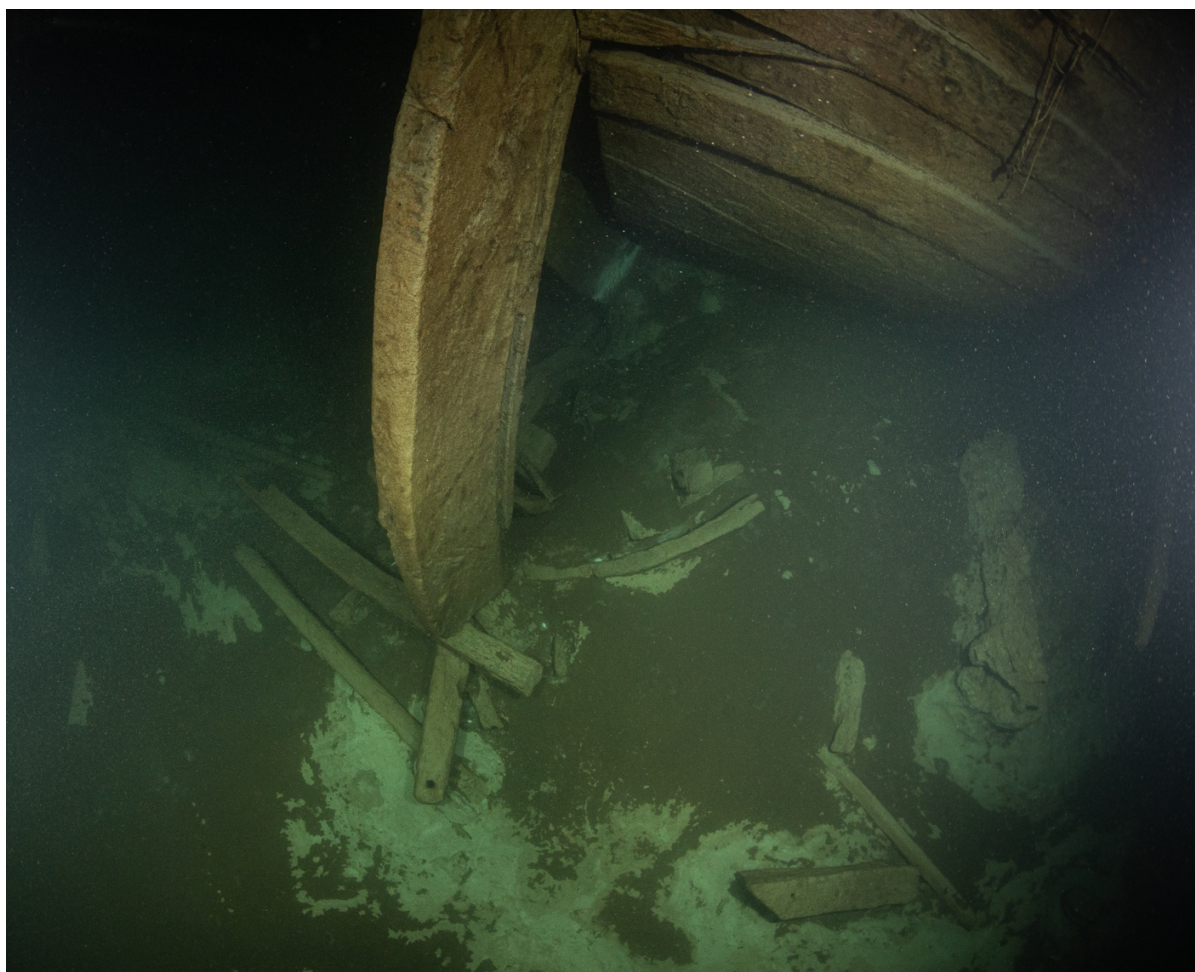
**Figure 7.** The stempost resting on debris from the wreck. Notice the cut-in in the lower part of the post for connecting two parts of the post (Jouni Polkko 2020).

The stempost is made of several timbers and has a gammoning hole on top of it. The bowsprit rested on the top of stempost, and the hole was used for lashing the bowsprit to the post. The bowsprit and the prow are both missing. As mentioned earlier, the stempost has been broken in two from one of the joints between timbers because of a trawl. This is evident from the fact that the broken part of stempost rests on top of some wooden debris from the wreck. The length of the broken part is about 510 cm. The method for joining two parts of the stempost is clearly visible on figure 6. The break is two planks lower than the lowest wale. In front of the windlass there's a plank with a cut-in for the foremast. The windlass barrel is made of a large log and the windlass system is almost identical to the one on the "Ghost Ship" (see Eriksson and Rönnby 2012, 353). The barrel was rotated by hand levers that were inserted into the square holes in the barrel. As on the "Ghost Ship", the bearings for the windlass are made of two horizontal timbers attached to the inside of the bulwark. On the "Swan", the port side timbers for bearings are still intact and the barrel sits inside, but on the starboard side the barrel has been dislocated

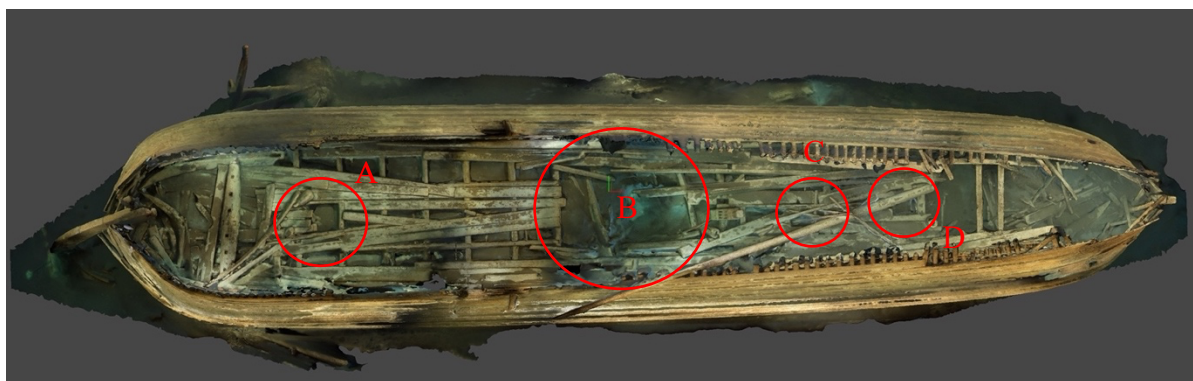
The main deck extends the whole way from the stempost to just behind the bilge pump. Aft of the windlass barrel there is a small hatch, right in the midship there's a main cargo hatch and it looks like there are two small hatches abaft main cargo hatch. Because the deck planking has been dislocated and now lies in disarray, the existence of two small hatches abaft the mainmast needs to be confirmed. However, there is one small hatch right in front of the intact bilge pump and it looks like the edges and cut ins in the deck planking of a little bit larger hatch few meters in front of the last hatch (see figure 8).

**Figure 8.** Hatches: A – small hatch in the bow, B – main cargo hatch, C – another possible hatch, D – small hatch in front of the bilge pump (Jouni Polkko 2021).

Compared to the Swedish *fluit* wrecks four cargo hatches would make this vessel unique as none of the other *fluits* in the Baltic Sea had four hatches. "The Lion Wreck" and the "Ghost Ship" had A, B and C hatch, but lacked the D hatch (Eriksson 2014). All the hatches have lost their coverings, probably already during sinking. Eriksson (*ibid.*) claims that decks, hatches and bulkheads on *fluits* were following a standardised pattern. It raises a question what was the purpose of the fourth hatch? Where did it lead and why was it necessary?

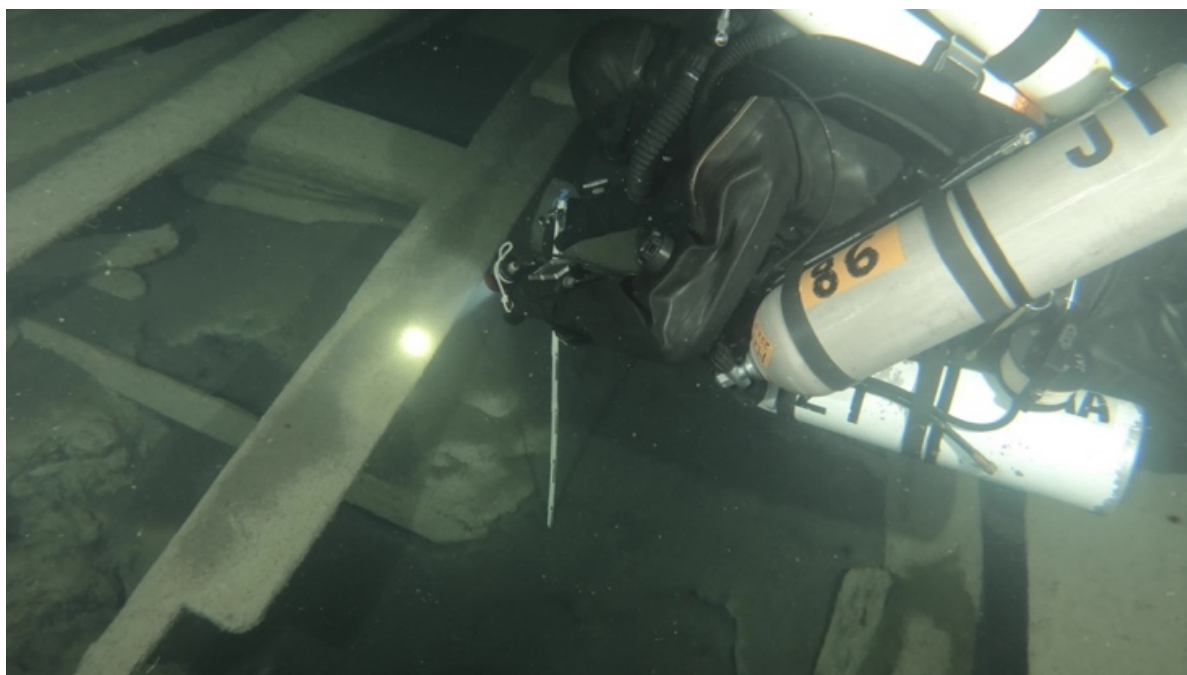
It is unclear if the hold is full or not, because only a thick layer of sediment is visible. However, since the sediment layer starts just below the deck level it stands to reason that the vessel was not in ballast when she sank. The thickness of the sediment layer was measured using a measuring stick in the main cargo hatch (see figure 9). The results were between 22 and 40 cm in four different measuring locations. Something solid was felt underneath. It is possible that the measuring stick hit a lower deck (also called orlop deck) – a deck between the main deck and the cargo hold. Lower deck had a height of 1,2–1,5 meters and was used for storing loose or lighter items like barrels or crates and items that were supposed to stay dry (Hoving 1995, 48; Eriksson 2015b, 52). Lower deck did not necessarily stretch out the whole length of the ship, it could start just abaft the main cargo hatch and some *fluits* like the "Jutholmen Wreck" did not have a lower deck at all (Eriksson 2015b). Considering the size of the "Swan" she probably had a lower deck, but this yet needs to be proven. Another possibility is that the stick hit the cargo. Removal of the sediment can give an answer to that. The distance between the beams under the main deck from forward small hatch to main cargo hatch is approximately 132 cm (measured from the model). Two of the beams have fallen into the hold and the deck planking is in disarray so the exact position of the main hatch is difficult to establish from the 3D model.

**Figure 9.** Measuring the sediment layer in the main cargo hatch (Ivar Treffner 2021).

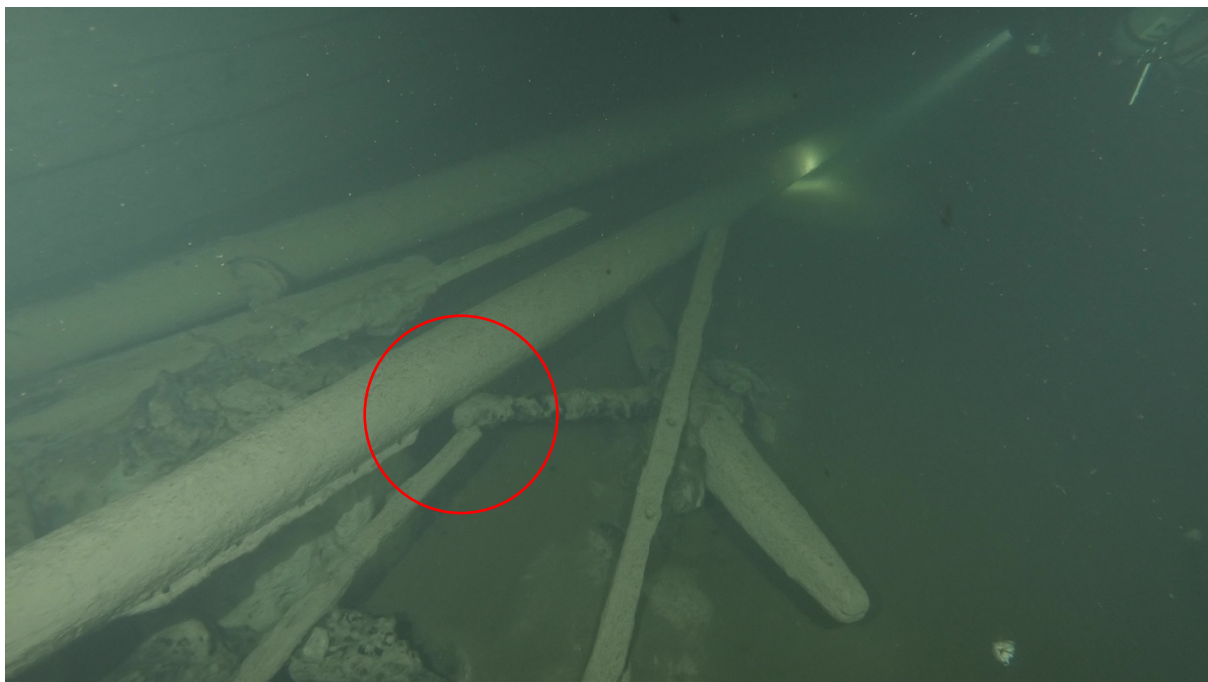
century (Marlowe 2017). It appears that one of the port side anchor's shank is broken (figure 11). Originally these anchors would have been tied to the hull. Either the binds holding the anchors have rotten and broken or the anchors have been dislocated by a trawl (which could explain the broken shank). However, the former seems more likely than the latter, considering the position of the anchors. If caught in the trawl while still attached to the hull, the anchors should be further away from the hull and their current positions, or they would be completely missing. Also, parts of the rigging have fallen over the anchors, suggesting that the anchors were on the seabed when the masts fell or were trawled down. It is possible that a yard that fell on the anchor broke the shank.

**Figure 11.** Stock and broken shank (highlighted with red circle) of the second port-side anchor (Ivar Treffner 2021).

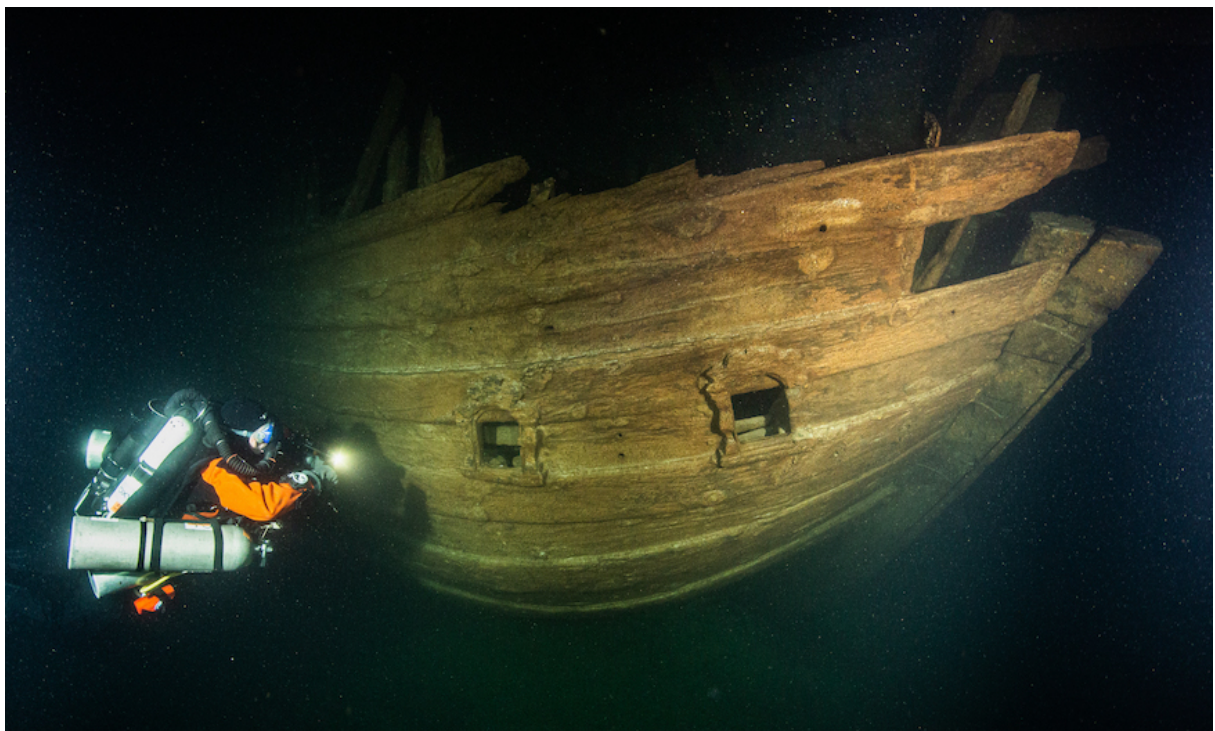
Surprisingly, the only surviving ornaments on the "Swan" are the carvings around the windows (see figure 11), on the rudder and the transom (the latter will be discussed separately). The carvings around the windows follow the common flower-like motif which was typical for Holland (Eriksson and Rönnby 2012). No carved ornaments were found in the bow section. All three of the bitts found on board the "Swan" do not feature any carvings – usually the tops of the bitts were carved with heads of merchants or military figures in case of warships. This is highly unusual for a *fluit* – both "The Lion Wreck" and the "Ghost Ship" featured carved knightheads and lavish carvings in the stern (see Eriksson 2012, Eriksson and Rönnby 2012). No *hoekmen* were found in the stern. This does not necessarily mean that there were no *hoekmen*. Carvings were fixed to the ship's hull with iron nails which will rust, and the wood gets soft over time (Arrison 1994, 160, Eriksson 2014, 86). Considering this, it's possible that the *hoekmen* have just fallen off their original position or have been removed by the trawl. There is a large debris field all around the wreck which is still waiting for research. Divers

**Figure 11.** Carvings around the windows. Note the two holes between the windows that were probably used for opening and fixing the window hatches (Jouni Polkko 2020).

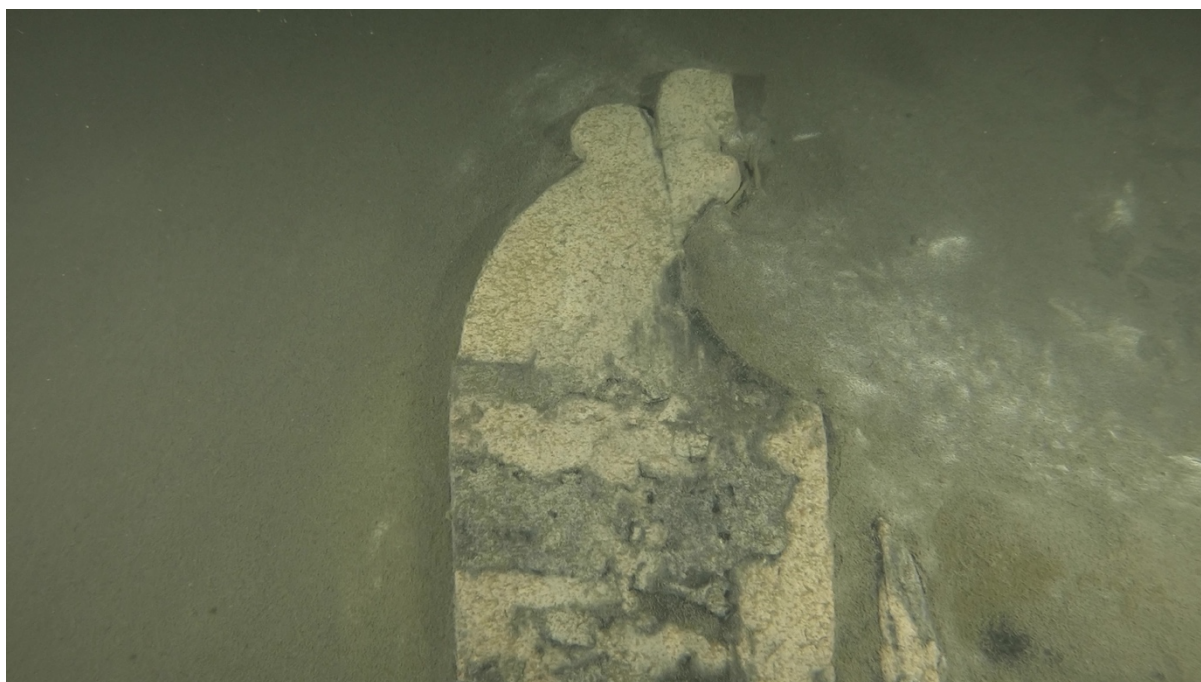
**Figure 12.** Carving on top of the rudder (Ivar Treffner 2021).

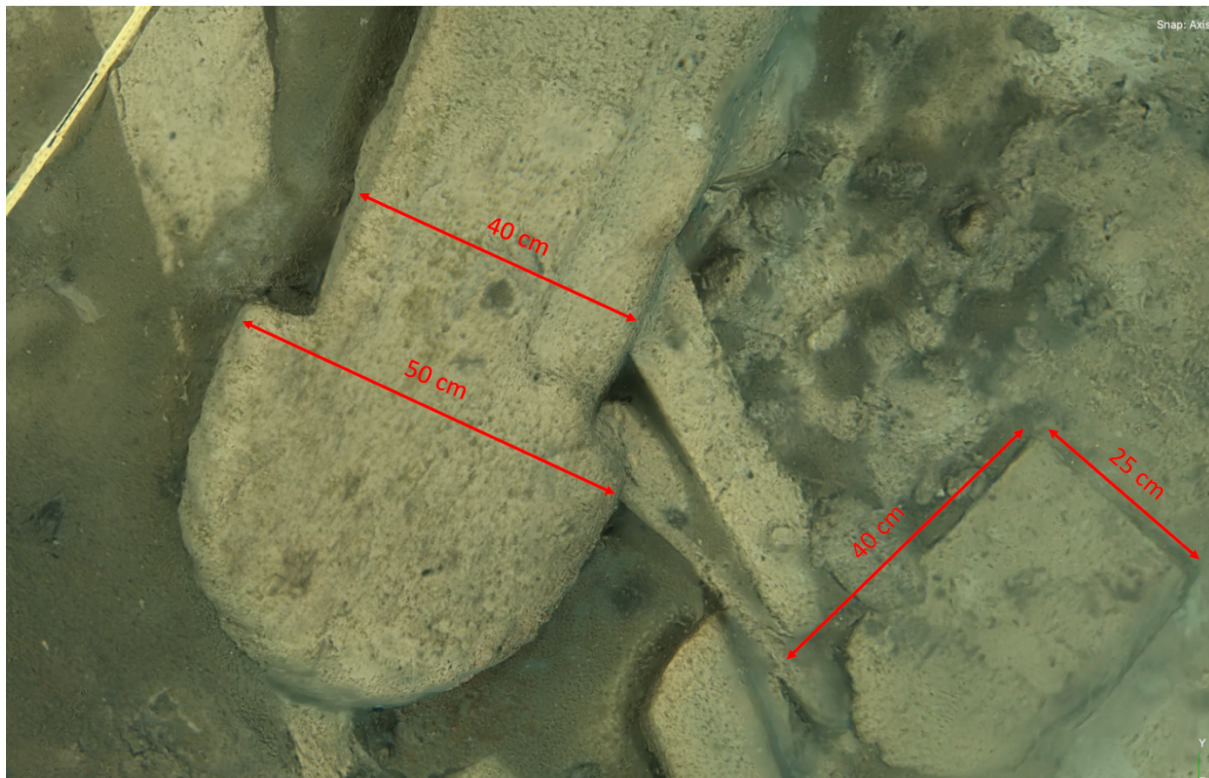
**Figure 13.** The transom in its original position, presumed coat-of-arms and its dimensions on the lower right corner (Jouni Polkko 2021).

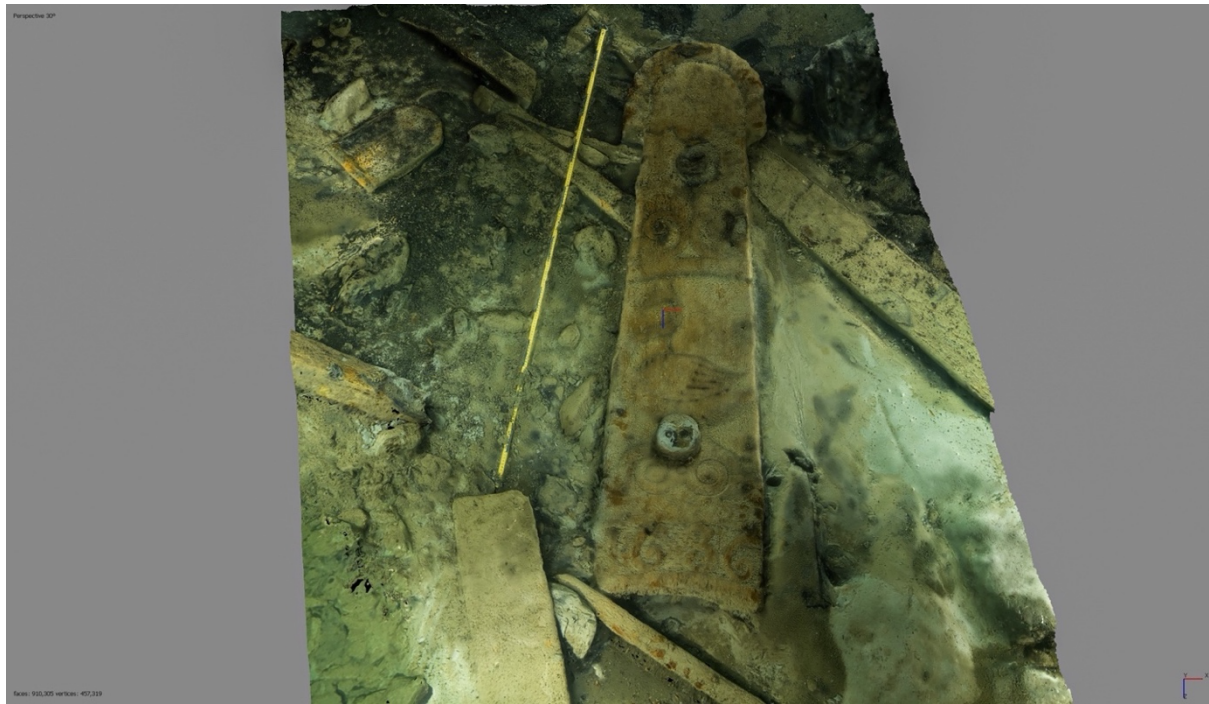
**Figure 14.** The transom after being flipped around (Jouni Polkko 2021).

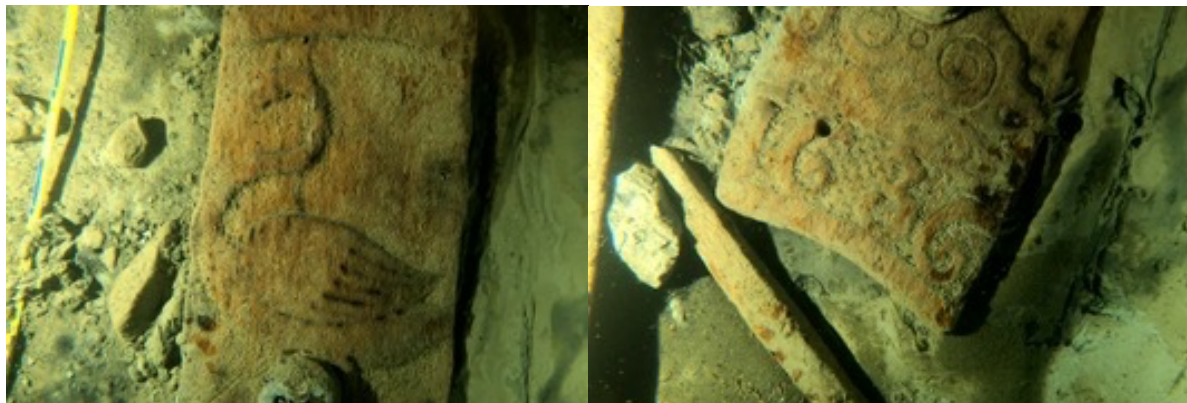
than the estimates for other well-preserved *fluits*. The swan depicts the name of the vessel. "Swan"-themed names were quite common on *fluits*. The "Ghost Ship" could have also been named similarly, because a sculpture of a bird resembling a swan was found on the seabed next to the stern (Eriksson 2014, 156). Under and above the swan figure spiral decorations can be seen. Under the swan carving a two-holed deadeye is stuck to the transom. Two-holed deadeyes were not as common as three-holed deadeyes and were mostly used on parrel rope for the mizzen yard, making it possible to control the yard from the deck. It makes sense to find this type of the deadeye in the stern area. The deadeye had probably fallen to the seabed when the ship sank or when the rigging rotted away and once the nails holding the transom rusted, it fell upon the deadeye. Or it could have happened when the trawl damaged the wreck, but that probably did not happen so long ago for the deadeye to get fixed on the transom. Immediate inspection of the transom did not reveal the coat-of-arms of the home port and so it was assumed that the smaller wooden plank close to the transom may be the coat-of-arms. The author does not consider himself an expert on wooden carvings, but even to an untrained eye the carvings on the transom seem rather simplistic and not too elaborate.

**Figure 15.** Carvings on the transom – the swan (left) and 1636 (right) (Jouni Polkko 2021).

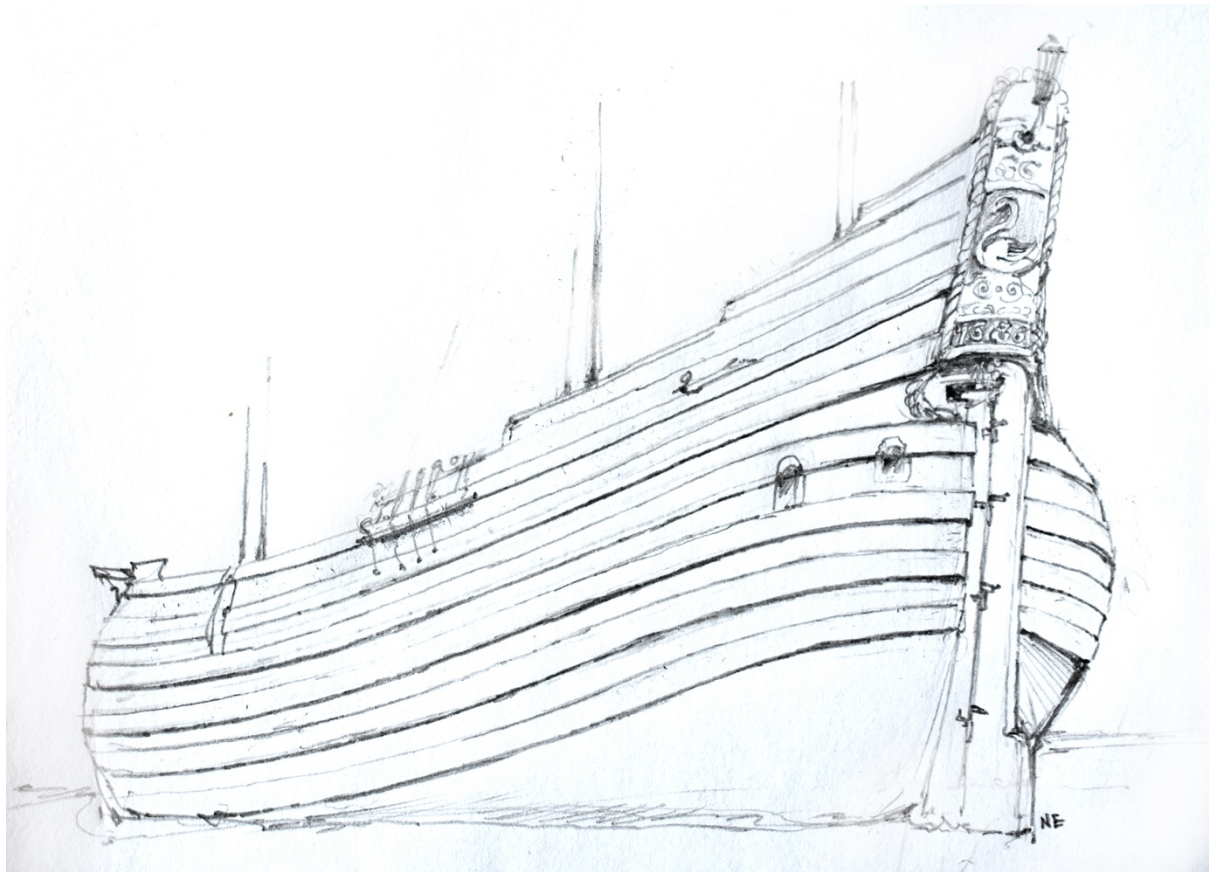
**Figure 16.** Artist's interpretation of the "Swan's" stern (drawing by Niklas Eriksson 2021).

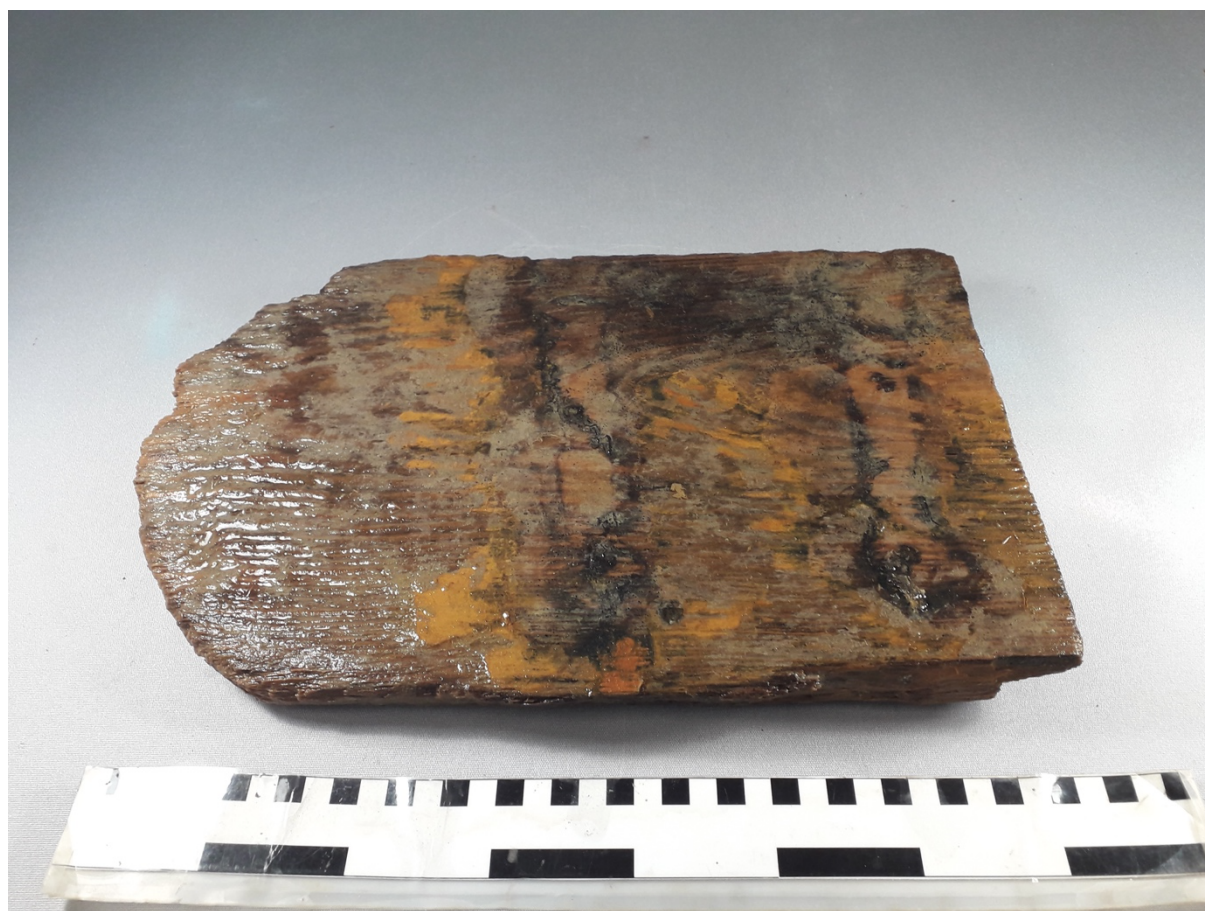
Since no coat-of-arms was found on the transom, it was decided in consultation with Finnish Heritage Agency representative during the fieldwork to recover the wooden plate thought to be the coat-of-arms. Because of the small size and lightness of the object a mesh bag was used for recovery. Once surfaced the object was immediately put to protective plastic box filled with seawater. However, it was clear that the plate was not the coat-of-arms, but a window hatch. Judging by its location it probably used to cover one of the port side windows. The hatch has a cut-in on two sides on the inner side of the plate to fit snugly into the window opening. On the outer side clear marks from the hinges are still visible. Hinges have rusted away. A 3D model of the window hatch has been created and it can be viewed in Sketchfab<sup>13</sup>. The hatch itself is now in Finnish Heritage Agency's Collection and Conservation Centre. Samples for

**Figure 17.** Recovered window hatch, outer side with marks left by hinges (Liisa Näsänen, Kansallismuseo 2021).

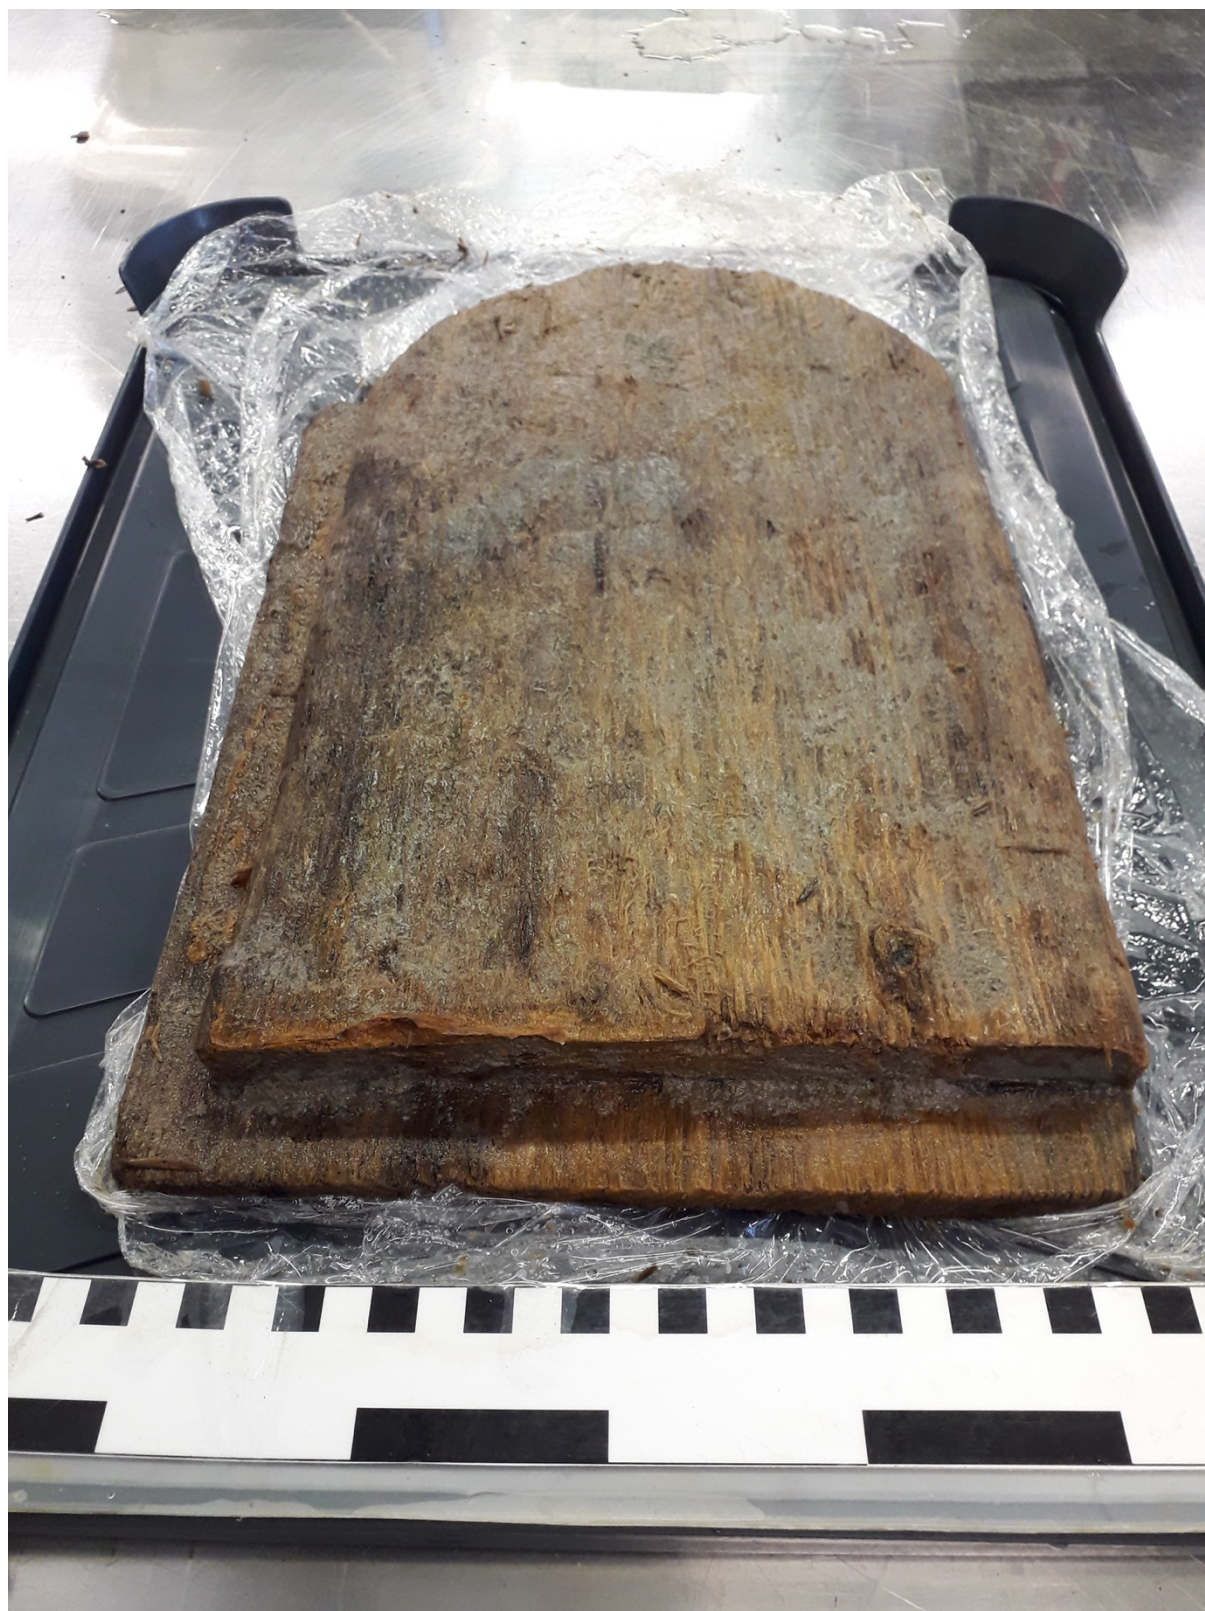
**Figure 18.** Recovered window hatch, inner side (Liisa Näsänen, Kansallismuseo 2021).
